## **City Commission Workshop Agenda November 19, 2018**

**SUBJECT:** Discussion of Former City Warehouse on Main Street

Limited Structural Evaluation  
**City of Alachua Main Street Warehouse**  
14815 North Main Street  
Alachua, Alachua County, Florida  
GSE Project No. 13630

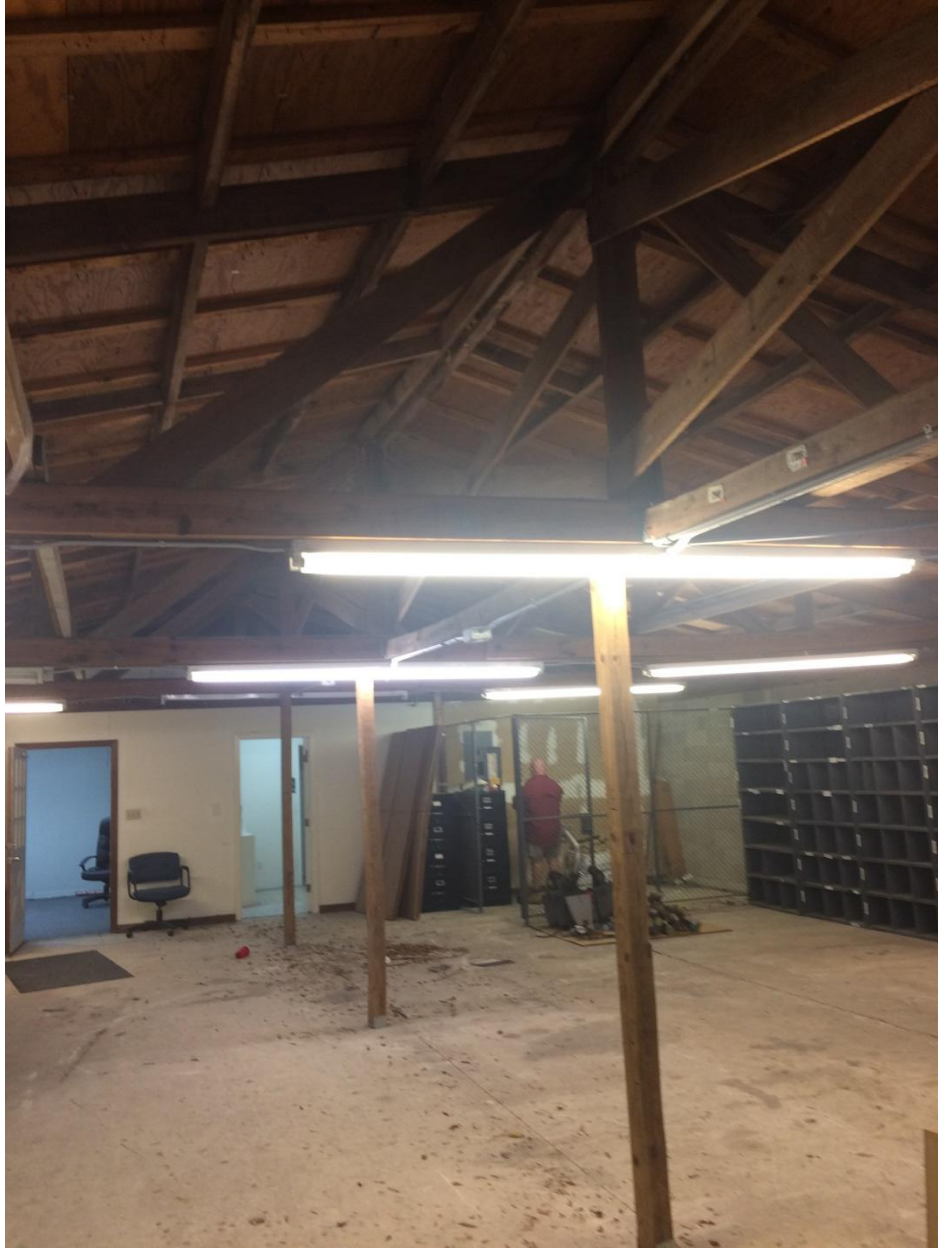
Picture 1  
Interior of Warehouse Portion

The structural framing and floor slab for the north warehouse portion of the building was uncovered and observable (see photo No. 1). The structural framing for the office areas on the south side (approximately 600 square feet) was covered by drywall, and the floors were covered with carpet (see photo No. 2). The foundation system for the load bearing block walls was buried and unobservable at the time of our site visit.

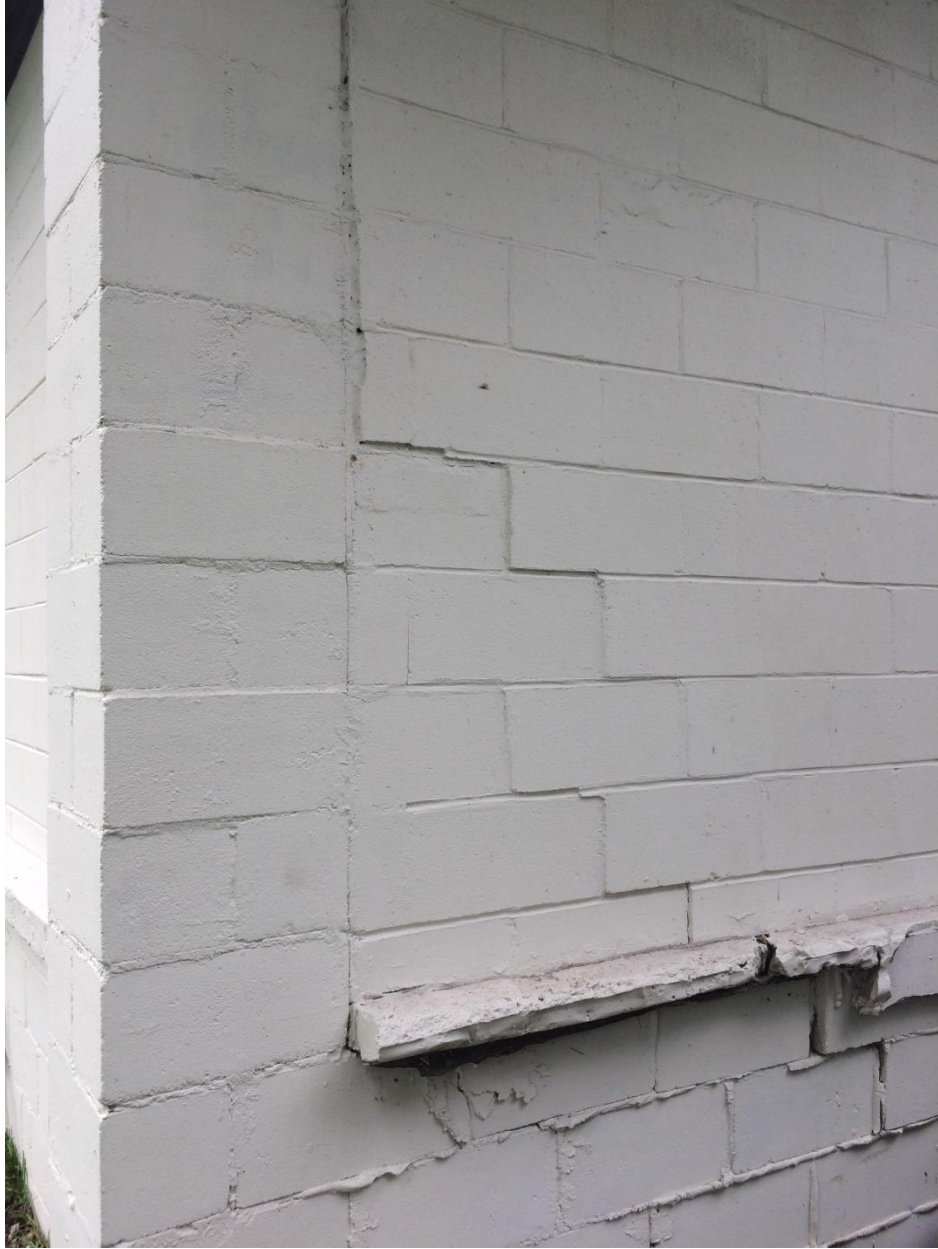
Picture 3  
Northeast Corner CMU

- The northeast corner had cracking damage to the concrete masonry unit (CMU) load bearing walls (see photo No. 3). This damage appears to be related to the root system of a large tree that was removed in the past, and had been previously repaired. The conditions of the repairs do not appear to be appreciably worse than the completed repairs would have looked like immediately after completion. Further destructive investigations are required to determine how the CMU walls in this area are reinforced. It is GSE's opinion that additional reinforcing is most likely required to bring the wall strength up to Code requirements.
- The roof system has large deflections throughout (see photo No. 4). This coincides with the deflections and design/construction observed inside the building. No appreciable roofing damage was observable from our vantage point on the ground.

To keep and use the existing CMU walls and foundations, additional destructive testing would be required to determine what modifications would be required. At the least, the CMU walls in the northeast corner would require added reinforcing grouted into the existing cells of the wall. We estimate the cost of the investigation and repairs to be on the order of \$20,000.

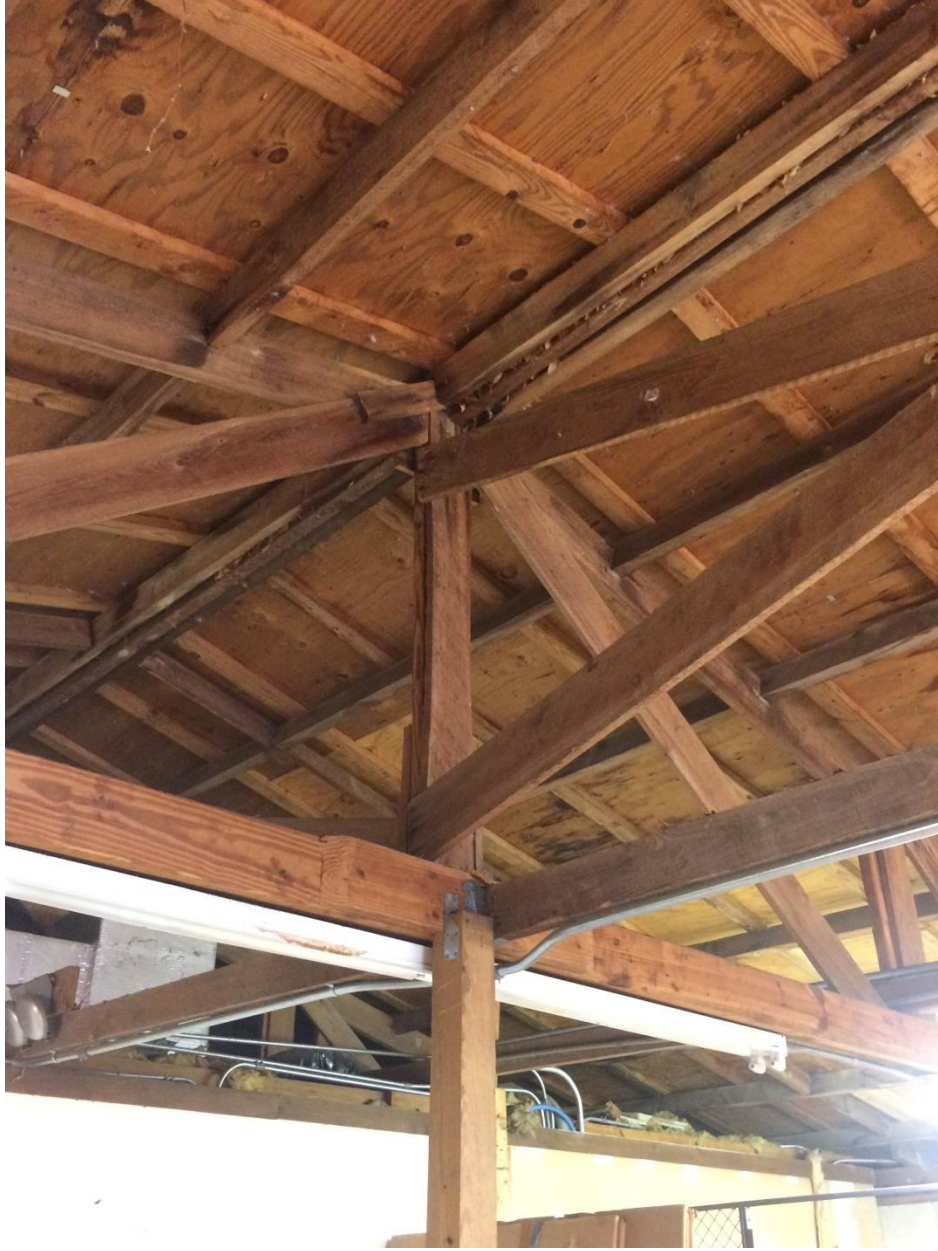
Picture 6  
Column to Shore Roof Framing

The existing roof framing of the warehouse is considered inadequately designed and constructed, and requires complete replacement. During a wind event, the roof framing could pose a safety hazard for anyone occupying the building. We estimate the cost of demolition and replacement will be on the order of \$80,000.

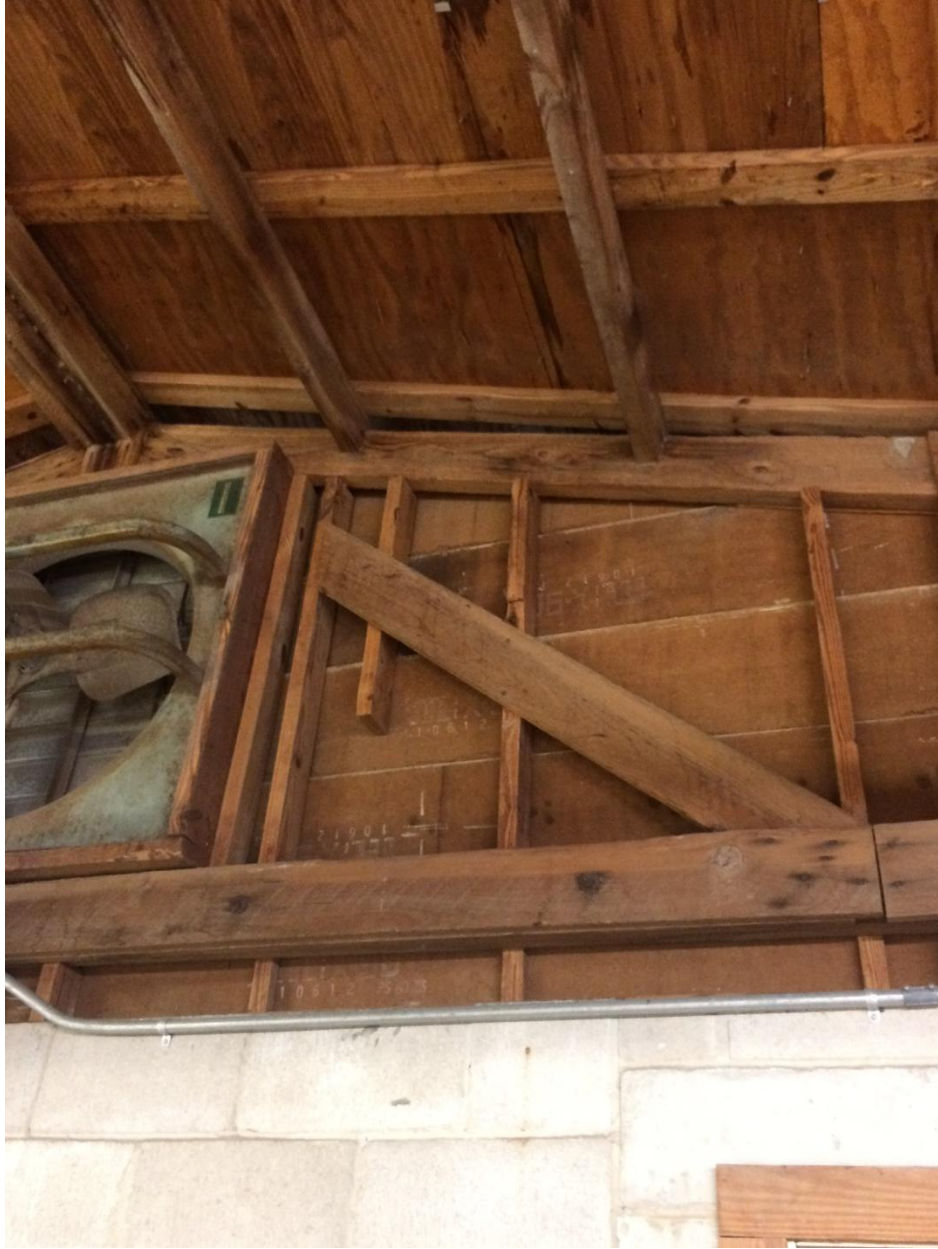
Picture 7  
Bracing Disconnected with Panel Points

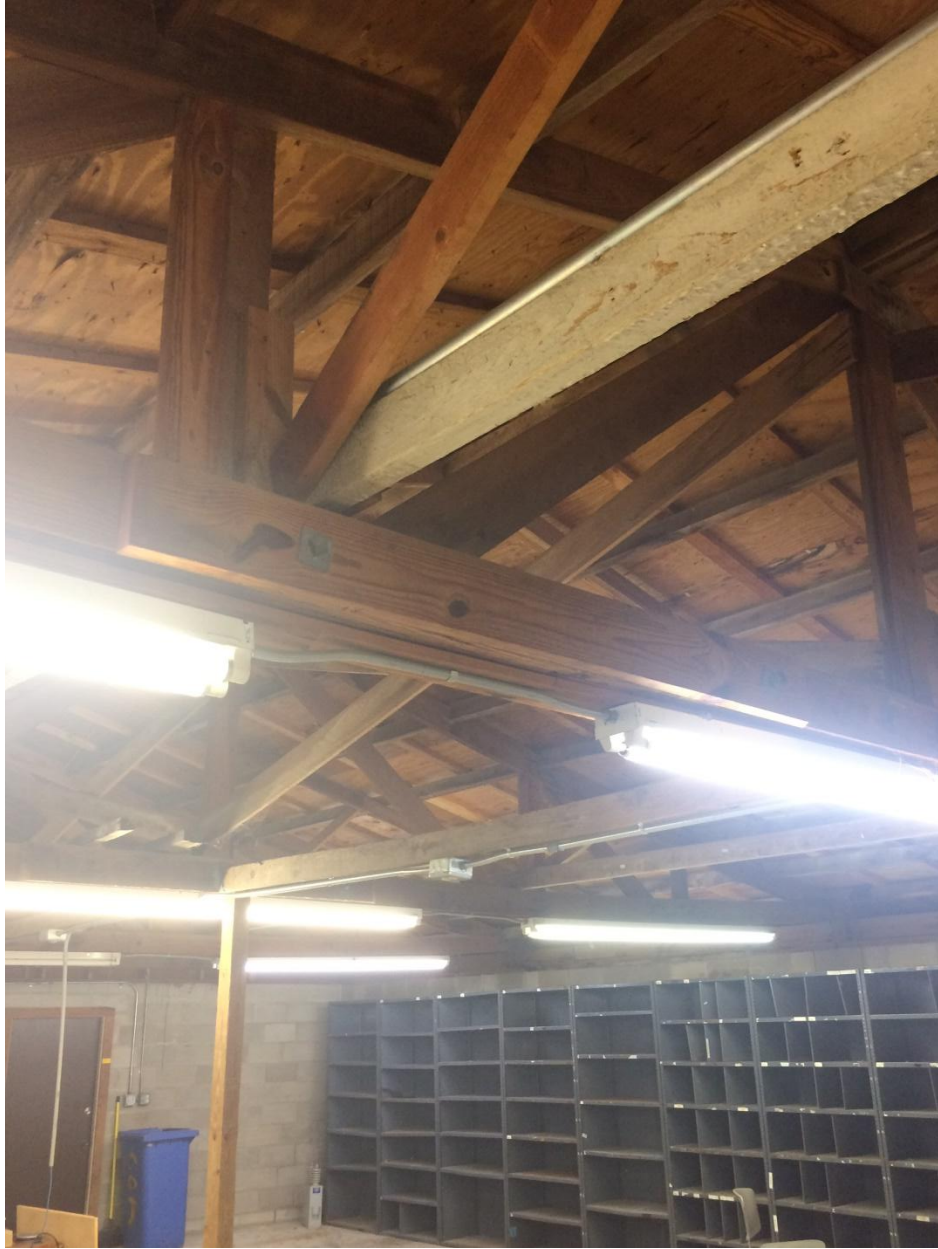
Picture 8  
Haphazard Bracing System
